Kegagalan *Heave-Up* Jangkar pada MV. Warih Mas di Teluk Palu

Anchor Heave-Up Failure of MV. Warih Mas in Palu Bay

Lilik Prayogi^{1*}, Muhammad Sapril Siregar², Eka Nurmalia³

^{1,2,3} Politeknik Pelayaran Malahayati, Aceh

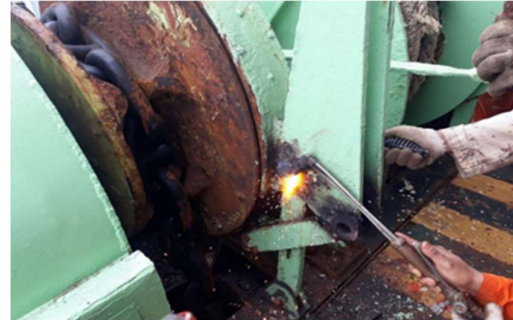
The main factor causing the anchor heave-up failure of the MV Warih Mas was corrosion in the anchor chain. The chain's corrosion caused the anchor chain's diameter to shrink, resulting in the anchor chain not attaching perfectly to the windlass drum. When the windlass drum rotates, but the anchor chain

does not rotate, the anchor cannot be lifted from the seabed. The corrosion occurring in the anchor chain was caused by stagnant water in the chain locker for an extended period due to the ship's crew's lack of inspection and maintenance. They failed to detect the stagnant water in the chain locker.

Figure 2. Corrosion of the Chain Link

The researchers found that the crew had been negligent in carrying out their duties and responsibilities, resulting in the chain locker being waterlogged for an extended period of time. This led to corrosion and shrinkage of the anchor chain, causing it to not attach properly to the windlass drum. As a result, the anchor chain did not rotate when the windlass drum rotated, making it impossible to lift the anchor from the sea bottom.

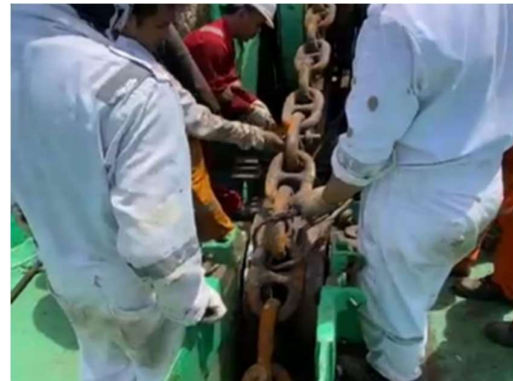
Figure 3. Inserting iron in the anchor chain on the windlass drum

described in detail by the researchers: a). The first experiment involved tying the anchor chain on the outside of the anchor screw using a spring rope and then pulling it using the left windlass to reduce the load of the right windlass during anchor heave-up. However, this experiment failed because the problem was not due to the weak windlass strength for anchor heave-up; b). The second experiment involved pulling the anchor chain with a chain block that was hooked onto the windlass body using a turnbuckle. However, the chain blockchain was cut due to a load that exceeded its capacity; dan c). The third experiment involved inserting iron in the anchor chain on the windlass drum so that the anchor chain rotated when the drum rotated. This allowed the crew to raise the anchor little by little over three days until it was successfully lifted entirely.

Then on the Palu-Jakarta departure, the windlass drum teeth were welded to reduce the gap between the corroded anchor chain and the windlass drum. This modification was tested until the ship's docking in November 2022, when the anchor chain was repaired or replaced with a new one.

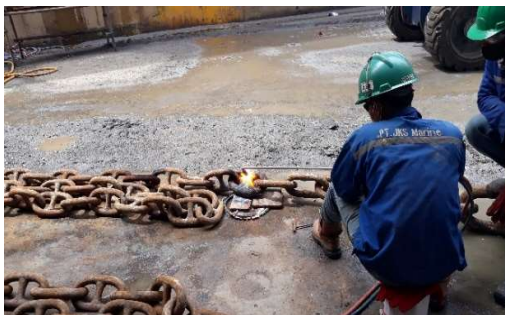
Figure 5. Replacement of Damaged Chain Links
